SHADI LAL BUILDING, LAHORE: A HISTORICAL AND ARCHITECTURAL ANALYSIS FOR CONSERVATION**Muti Ul Haq***Department of Architectural Engineering Technology, Punjab Tianjin University of Technology Lahore***Muhammad Zubair Khokhar***Department of Architectural Engineering Technology, Punjab Tianjin University of Technology Lahore***Nijah Akram****Department of Architectural Engineering Technology, Punjab Tianjin University of Technology Lahore***Ayesha Mehmood Malik***Associate Professor, School of Architecture, Faculty of Arts and Architecture, University of Lahore.***Saud Kamal***Assistant Professor, Multan College of Arts, Bahauddin Zakariya University Multan.***Zeshan Ashraf***Department of Architecture, University College of Art and Design, University of the Punjab, Allama Iqbal Campus, Lahore-Pakistan***Sami ur Rehman***Department of Architectural Engineering Technology, Punjab Tianjin University of Technology Lahore*

Shadi Lal, a monumental masterpiece of Mughal architecture, urgently demands comprehensive restoration and preservation efforts. This research seeks to address documentation and preservation issues related to the Shada Lal building. This project analyzed the processe

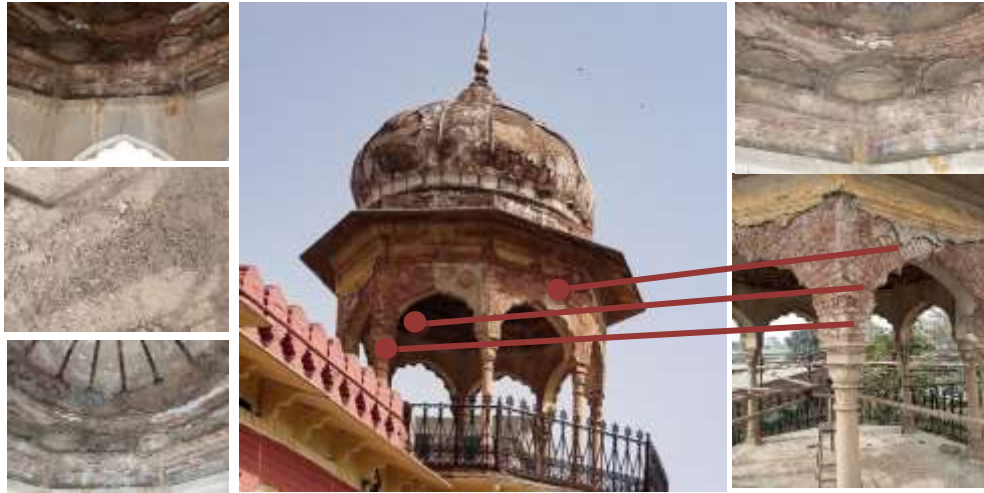
Figure 3. Right Minaret

Table 1. Right Minaret Decay Causes

Sr. #	Problems	Causes of Decay	Remedial Measures
1	Lime plaster is chipped off and the core structure is exposed.	Weathering effects especially rain, temperature variations, and no maintenance.	The bricks that are damaged should be coated again with lime mortar.
2	Lime plaster is chipped off and core structure is exposed and the molding work is also damaged.

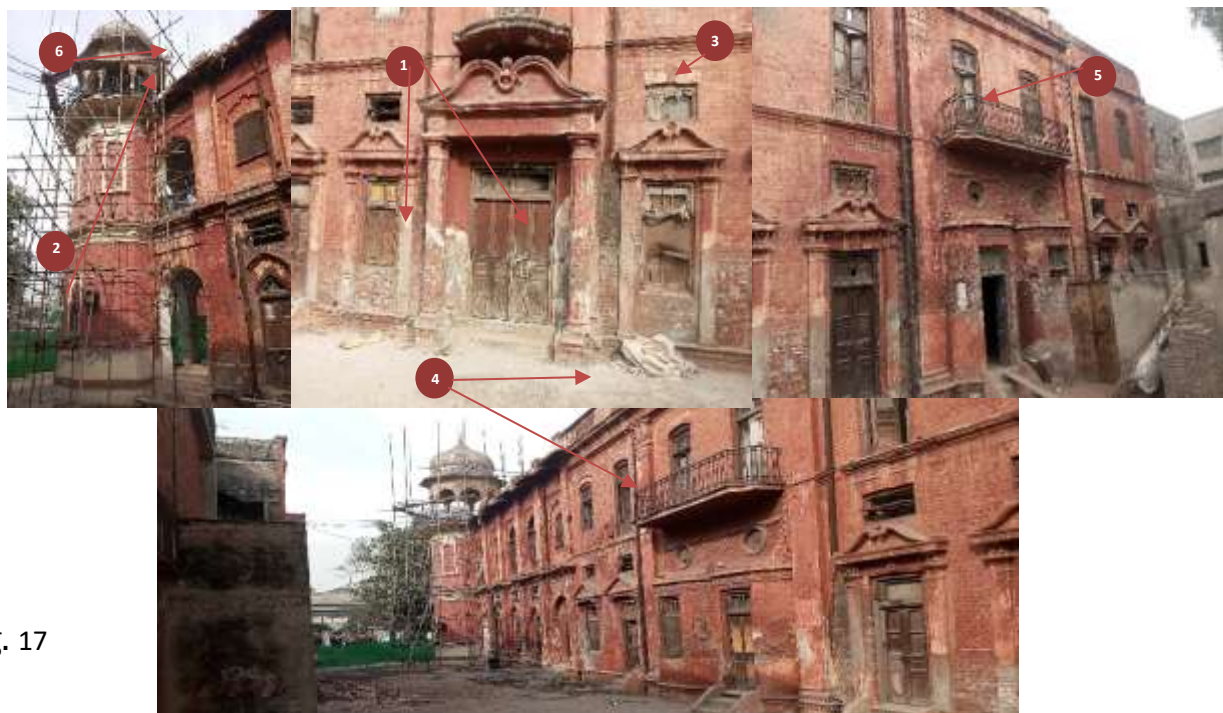
Figure 4. Right Elevation

Figures 4 and 5 of the building's exterior demonstrate an amalgamation of colonial and traditional architectural styles, characterized by arched entrances, intricate details, and a prominent dome. The upper-level balcony and windows exhibit extensive damage, evidenced by missing frames, collapsed sections, and clear signs of deterioration. The presence of scaffolding and debris indicates that conservation or restoration efforts are either underway or halted. The brickwork is severely deteriorated, with visibly crumbling bricks losing their original structural integrity. Plaster and decorative elements are either entirely eroded or partially visible beneath layers of dirt and overgrown vegetation. Wooden components, such as doors and window frames, appear to be either absent or profoundly decayed due to prolonged exposure to the elements. The foundation and lower walls demonstrate structural deficiencies, as evidenced by substantial cracks, missing

segments, and accumulated debris at the base.

Sr. #	Problems	Causes of Decay	Remedial Measures
1	Lime plaster is chipped off and the core structure is exposed.	Weathering effects especially rain, Temperature variations, and no maintenance.	The damaged bricks should be re-plastered with lime mortar.
2	Cracks	Weathering effects especially rain, Temperature variations, and no maintenance/ earthquake.	The Deteriorated portion of the plaster should be removed and fresh plaster be applied by using the same old technique and material.
3	Missing elements	No maintenance and earthquake destruction.	Replacement with the same Element
4	Damaged mortar and breakage/ missing structural portions.	Weathering effects, age and human vandalism by visitors and locals of the area. The seepage of the rain water causing moisture in masonry, corrosion and deterioration on the external surface of the monument thus producing cracks	The Deteriorated portion of the plaster should be

and breakage.	detached and fresh plaster be applied by using the same old methods and material.
5	Damaged motif and breakage/missing structural portions.	The seepage of the rain water causing moisture in masonry, corrosion and deterioration on the external surface of the monument thus producing cracks and breakage.	
6	Damaged mortar and breakage/missing structural portions.	Weathering effects, age and human vandalism by visitors and locals of the area. The seepage of the rain water causing moisture in masonry, corrosion and deterioration on the external surface of the monument thus producing cracks and breakage.

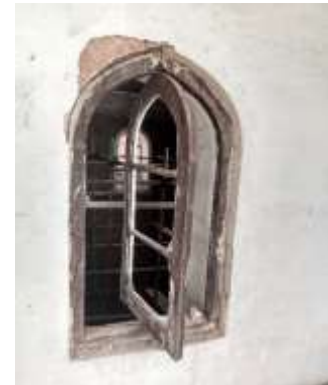
Figure 7. First-Floor Window

Figure 7, represents the first-floor windows, arched with detailed plaster moldings, these are now

heavily damaged, lacking glass panels, and having broken wooden frames. Some still have their wooden shutters, but most are either boarded or completely removed, leaving the interior exposed. The lack of protective features like grilles or iron bars indicates the building was not designed for high-security purposes.

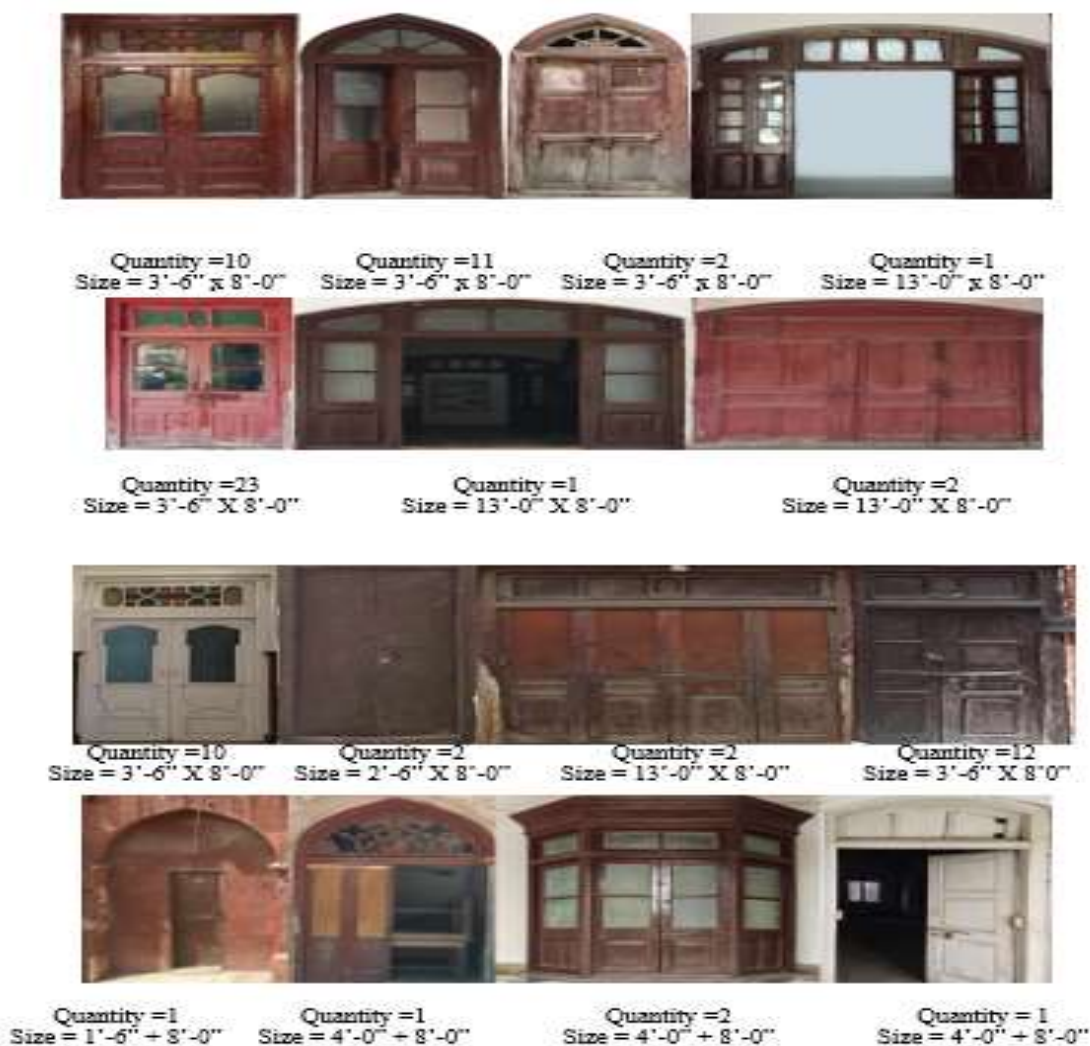
Figure 8. Entrance and Doorway

The centrally located main entrance features a decorative pediment, now partially ruined as shown in Figure 8. The entrances have carved wooden doors, though most are missing, broken, or decaying due to exposure. Some doorways have scaffolding, signaling ongoing restoration work. On the first floor, a projecting balcony with an ornate cast-iron railing is among the building's most prominent features. The balcony is structurally compromised, with sections of railing missing and cracked supporting brackets. The outer plaster on the balcony walls is peeling, exposing the brickwork beneath. The parapet wall and cornices are partly damaged or missing, indicating structural instability. A domed structure on the side, possibly a chhatri (small dome pavilion), implies Mughal or Indo-Saracenic architectural influences. The roofline seems to have suffered moisture damage, leading to vegetation growth and material weakening. The exposed bricks have become fragile and powdery due to long-term weather exposure. Significant portions of plasterwork have detached, especially around window frames and cornices. Plants growing through cracks point to moisture retention, which accelerates decay. Visible scaffolding and rubble piles indicate restoration work is underway.

The balcony, cornices, and parapet need urgent support and repairs to prevent collapse. Reinstallation of historically accurate wooden windows and doors can conserve authenticity. Carefully restoring decorative plaster elements can restore the building's original appeal. Moisture management through proper drainage systems is crucial to prevent further degradation.

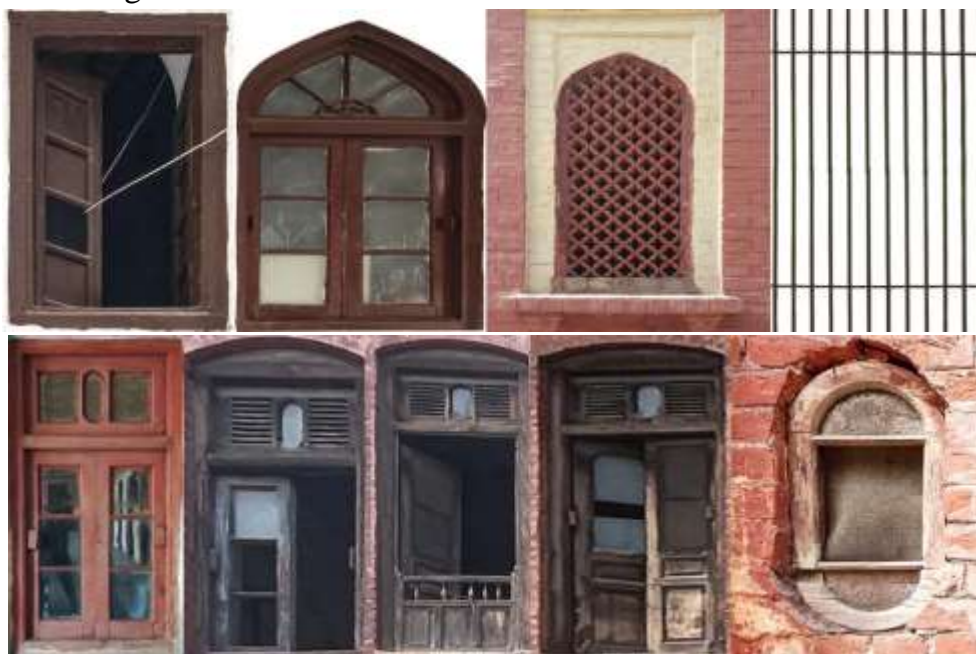
Figure 9. Exterior Façade Windows

In Figure 9 the windows of the Shadi Lal Building embody a unique fusion of Mughal, Colonial, and Indo-Saracenic architectural styles, highlighting exquisite craftsmanship in wood, glass, metal, and stone. Although they hold historical importance, these features have undergone significant deterioration due to moisture, termite infestation, corrosion, and weather exposure. To preserve these windows, a scientific yet thoughtful conservation method is necessary, integrating traditional restoration practices with modern materials to ensure longevity while preserving authenticity. Through the use of thorough documentation, treatments specific to each material, and strategies for adaptive reuse, the architectural integrity of these windows can be protected, enabling them to continue representing the building's historical and cultural heritage.

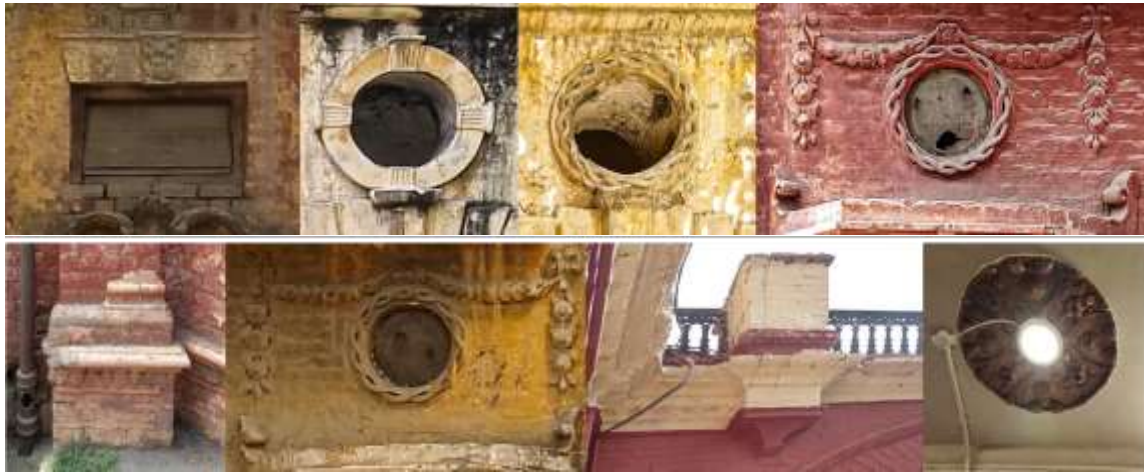
Figure 10. Ventilation/Building Openings

In Figure 10 the brackets and cornices are adorned with elaborate floral and geometric carvings, serving both structural and decorative functions, although many are deteriorating due to material

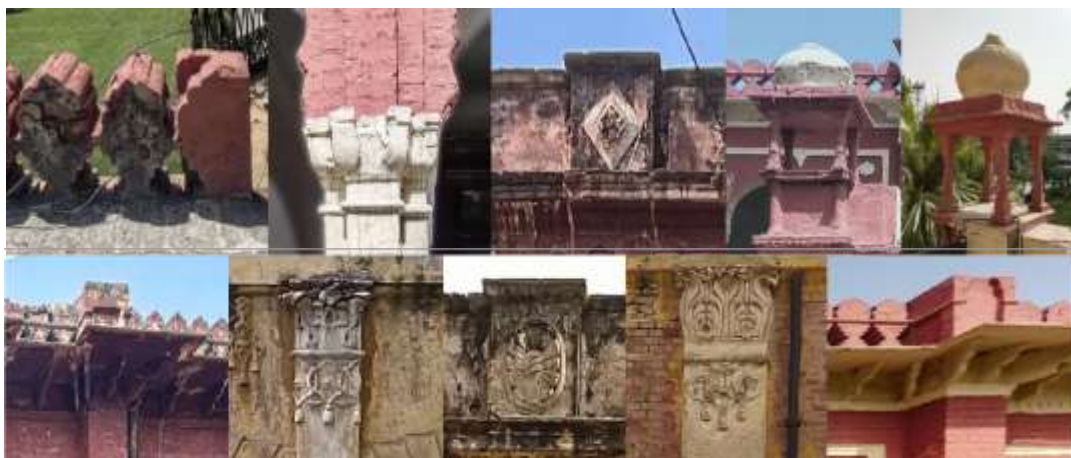
Figure 11. Elements of Exterior Facade

degradation. The pilasters and capitals, adorned with intricate relief carvings, confer grandeur to the facade but exhibit signs of chipping and surface erosion over time. The chhatris (domed kiosks), supported by slender columns, remain as vestiges of royal architectural expression, symbolizing prestige and authority, albeit now visibly marred by broken edges. Furthermore, the dentil molding and corbelled eaves augment the building's silhouette, exemplifying precise craftsmanship that necessitates urgent conservation efforts. The deterioration of these elements highlights the pressing need for restoration and structural fortification to conserve the historical integrity of the Shadi Lal building.

In Figure 11 the architectural composition of the Shadi Lal Building exemplifies an amalgamation of Mughal, Colonial, and Indo-Saracenic styles, highlighting intricate craftsmanship and substantial historical significance. The parapet walls incorporate merlons battlement-like elements traditionally employed for defensive and aesthetic purposes, albeit presently exhibiting significant damage and erosion. The brackets and cornices, adorned with floral and geometric carvings, function as both structural supports and ornamental enhancements, yet prolonged neglect has resulted in apparent material degradation and deterioration. The pilasters and capitals, intricately carved with foliate and scroll motifs, underscore the skilled craftsmanship of the period, though chipping and erosion pose a threat to their preservation. The chhatris—domed kiosks—that epitomize royal magnificence and architectural distinction rest upon slender columns yet display cracks, loss of stucco, and material degradation.

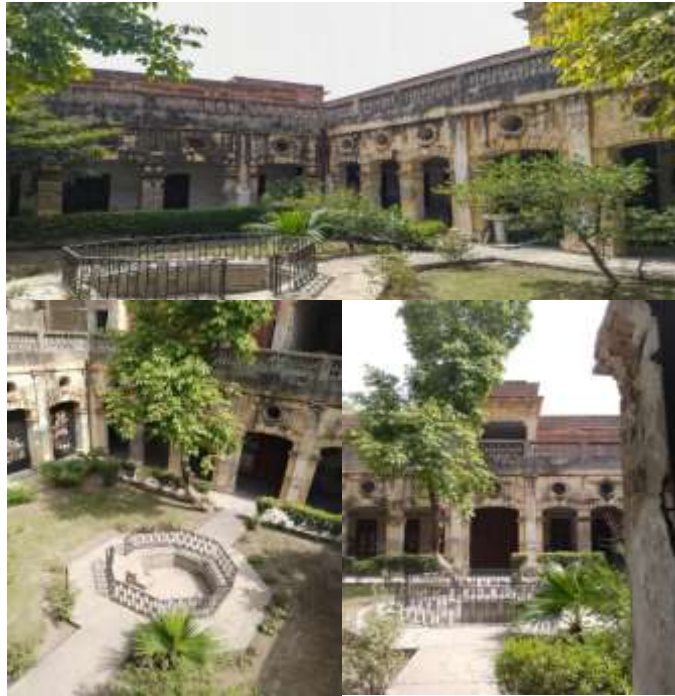
Figure 14. Courtyard & Fountain

In Figure 14 the central octagonal fountain hints at Mughal or colonial styles, utilized for their visual appeal and cooling effects. The fountain is surrounded by an iron fence, suggesting its preservation or modification over time. The edifice features arched entries upheld by classical columns and may reflect Indo-Saracenic or British colonial influences. Its facade displays signs of aging, like peeling plaster and visible bricks. The upper floor boasts a decorative parapet with geometric cut-outs, similar to lattice or jali designs employed for ventilation and aesthetics. Round ornamental indents on the walls may have been used as decorative alcoves or for ventilation purposes. The rich greenery, including pruned bushes and trees, indicates attempts to preserve the area. The trees' proximity to the fountain implies the courtyard's design was intended to provide shade and cooling, a typical trait in historical homes and establishments.
